# Review of Ultimate Strength Assessment of Ageing and Damaged Ship Structures

M. Tekgoz<sup>1</sup> · Y. Garbatov<sup>1</sup> · C. Guedes Soares<sup>1</sup>

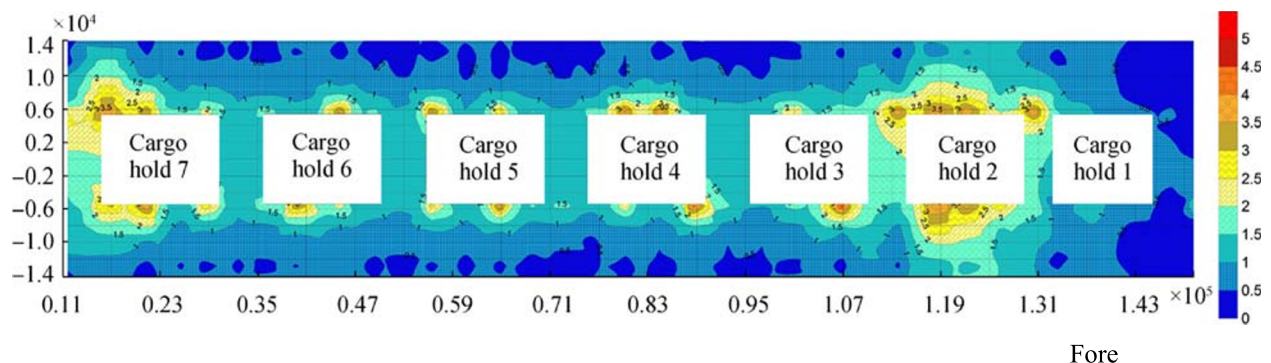
**Figure 1** Spatial distribution of corrosion thickness wastage on bulk carrier decks, 19th year (Garbatov and Guedes Soares, 2008)

Corrosion degradation of structures is one of the most severe problems in metal structures (see Figure 1). There are several environmental factors (Guedes Soares et al. 2009b; Guedes Soares et al. 2013) that cause the external steel plates to corrode, namely, the salty seawater, seawater temperature, pH and dissolved oxygen influence, sea flow, or ship routes. As for the internal plates, the degradation may be governed by the time in ballast, frequency of tank cleaning, temperature profiles, use of heating coils, humidity conditions, water and sludge accumulations, or microbial contaminations (Paik et al. 2003b).

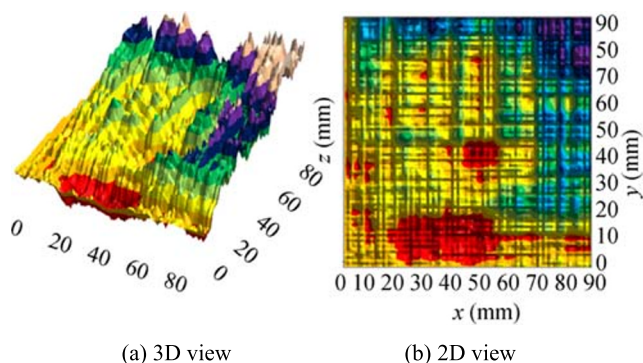
**Figure 5** Corroded plate surface (Garbatov and Guedes Soares, 2019). **a** 3D view, **b** 2D view

Due to the complexity in measurements of different structural imperfections, including corrosion degradation and initial distortions, the random field modelling (Teixeira and Guedes Soares (2008), Garbatov and Guedes Soares (2019), Woloszyk and Garbatov (2020)) provides a good way of stochastic modelling of corroded and deformed plate surfaces (see Figure 5).

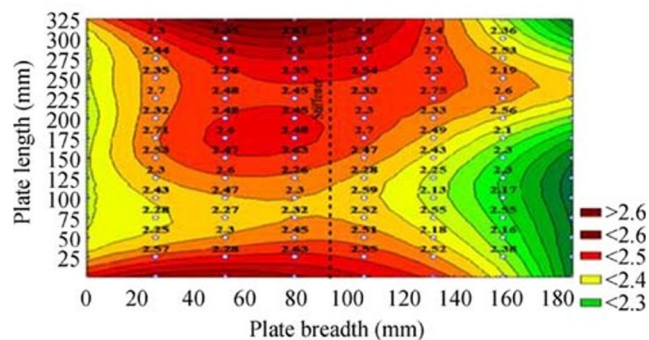
**Figure 6** Post-collapse deformed stiffened plate (a) and thickness distribution (b) (Garbatov et al. 2016b)

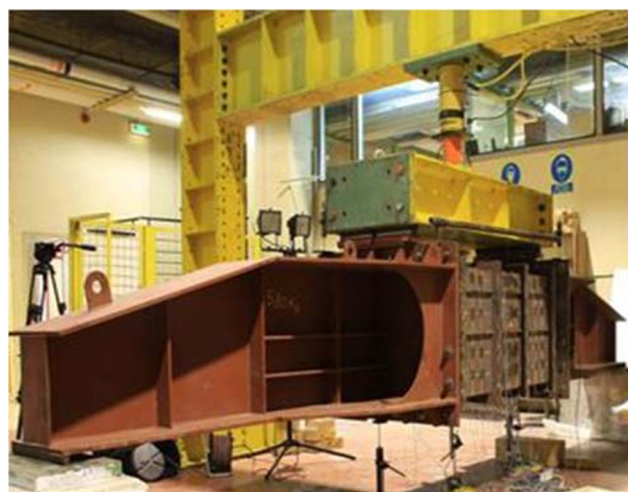
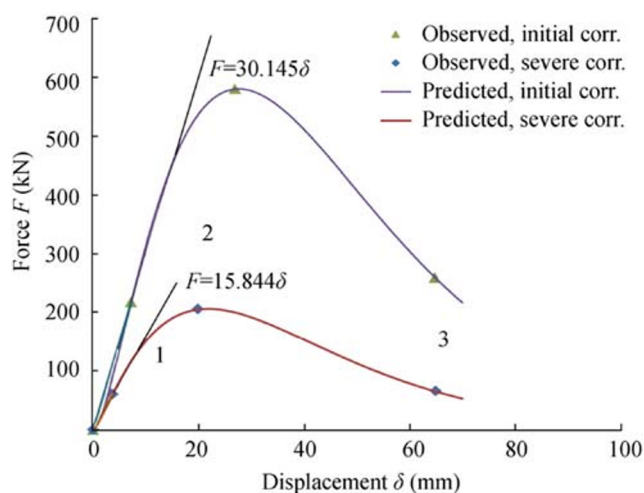
**Figure 7** Experimental set-up (a) and force displacement (b) (Saad-Eldeen et al. 2013c)

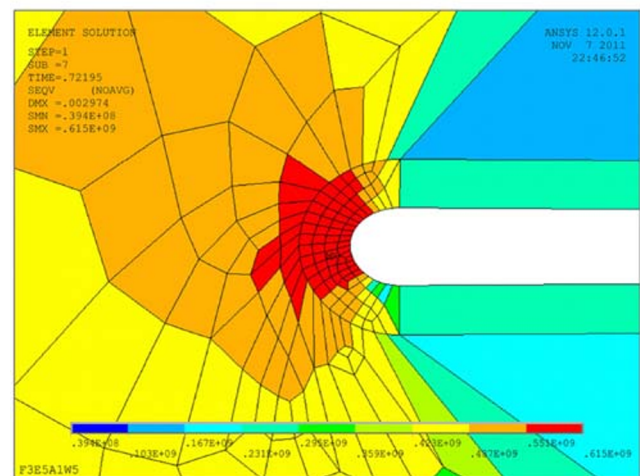
**Figure 10** Stress distributions at ultimate limit state for cracked panel (a) and local crack stress distribution (b) (Xu et al. 2014)

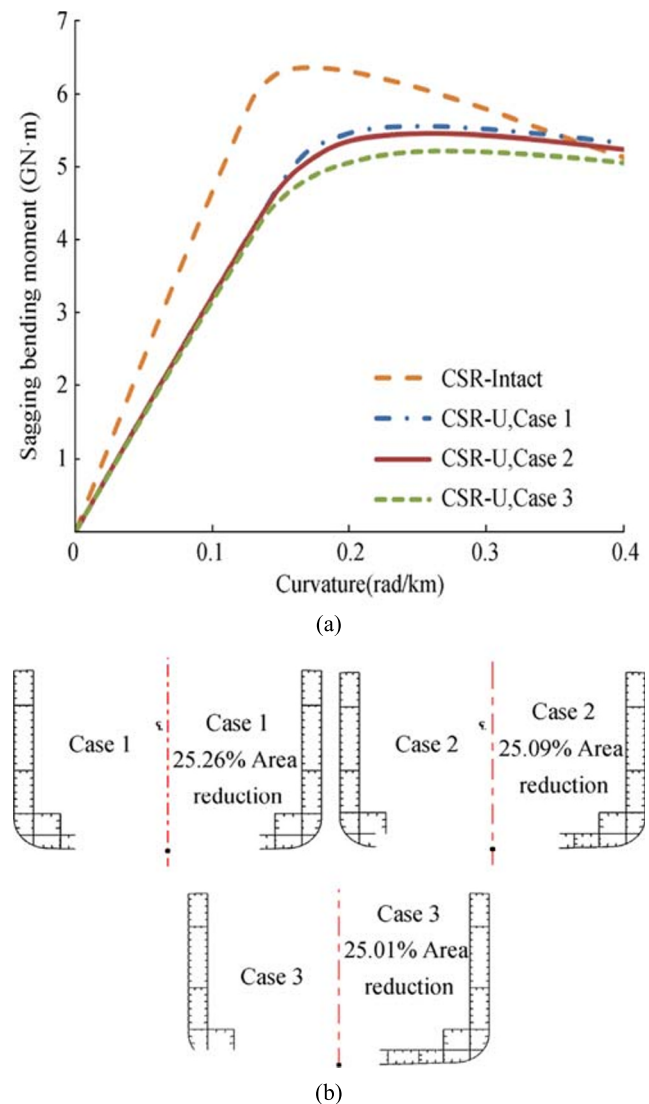
**Figure 11** Residual sagging bending moment-curvature relationship, 0 degrees of heeling (a) and damage case studied (b) (Tekgoz et al. 2018a)

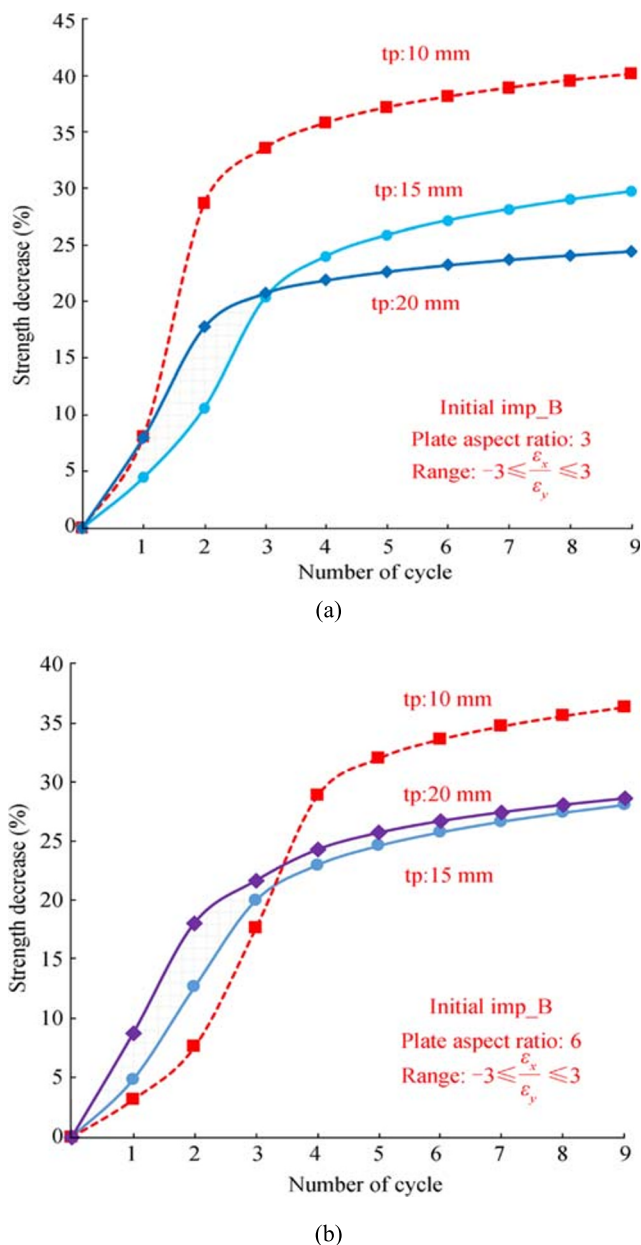
**Figure 12** Ultimate capacity decrease as a function of cyclic load, plate aspect ratio 3 (a) and plate aspect ratio 6 (b) (Tekgoz and Garbatov, 2020a)
